# Street Management Plan

Beaufort 2018 Pavement  
Present Status and  
Recommended Work  
Programs – Final Report

February 27, 2019

Town of Beaufort  
701 Front Street  
Beaufort, NC 28516

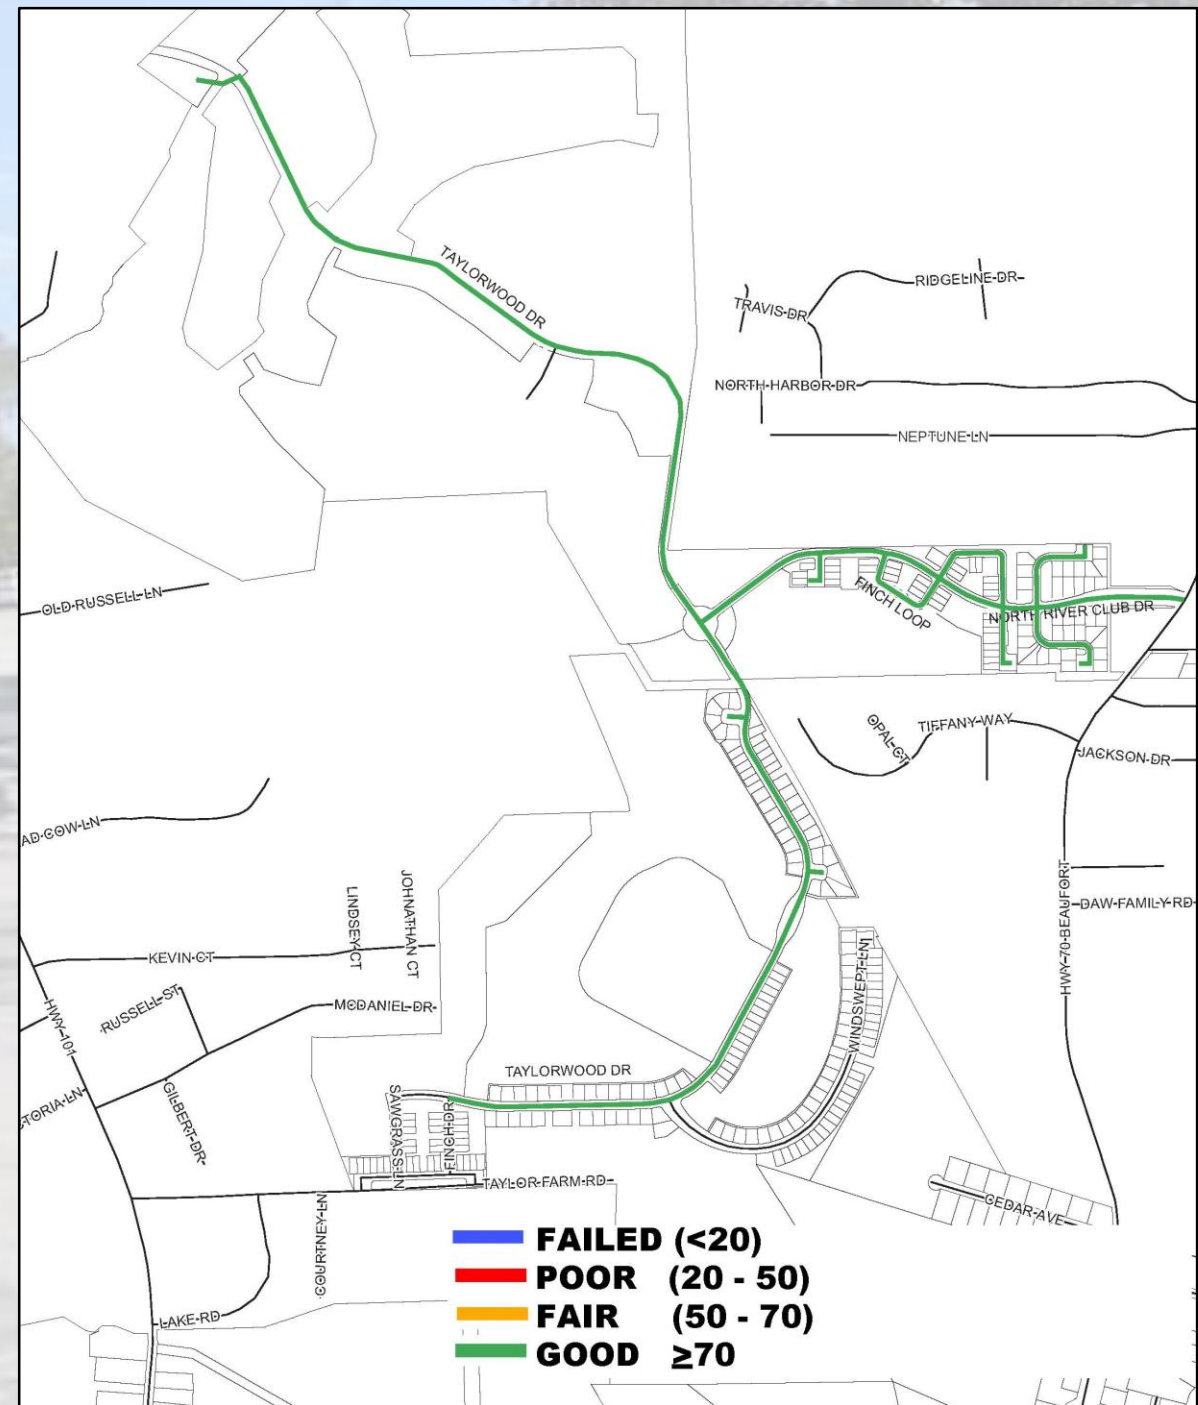
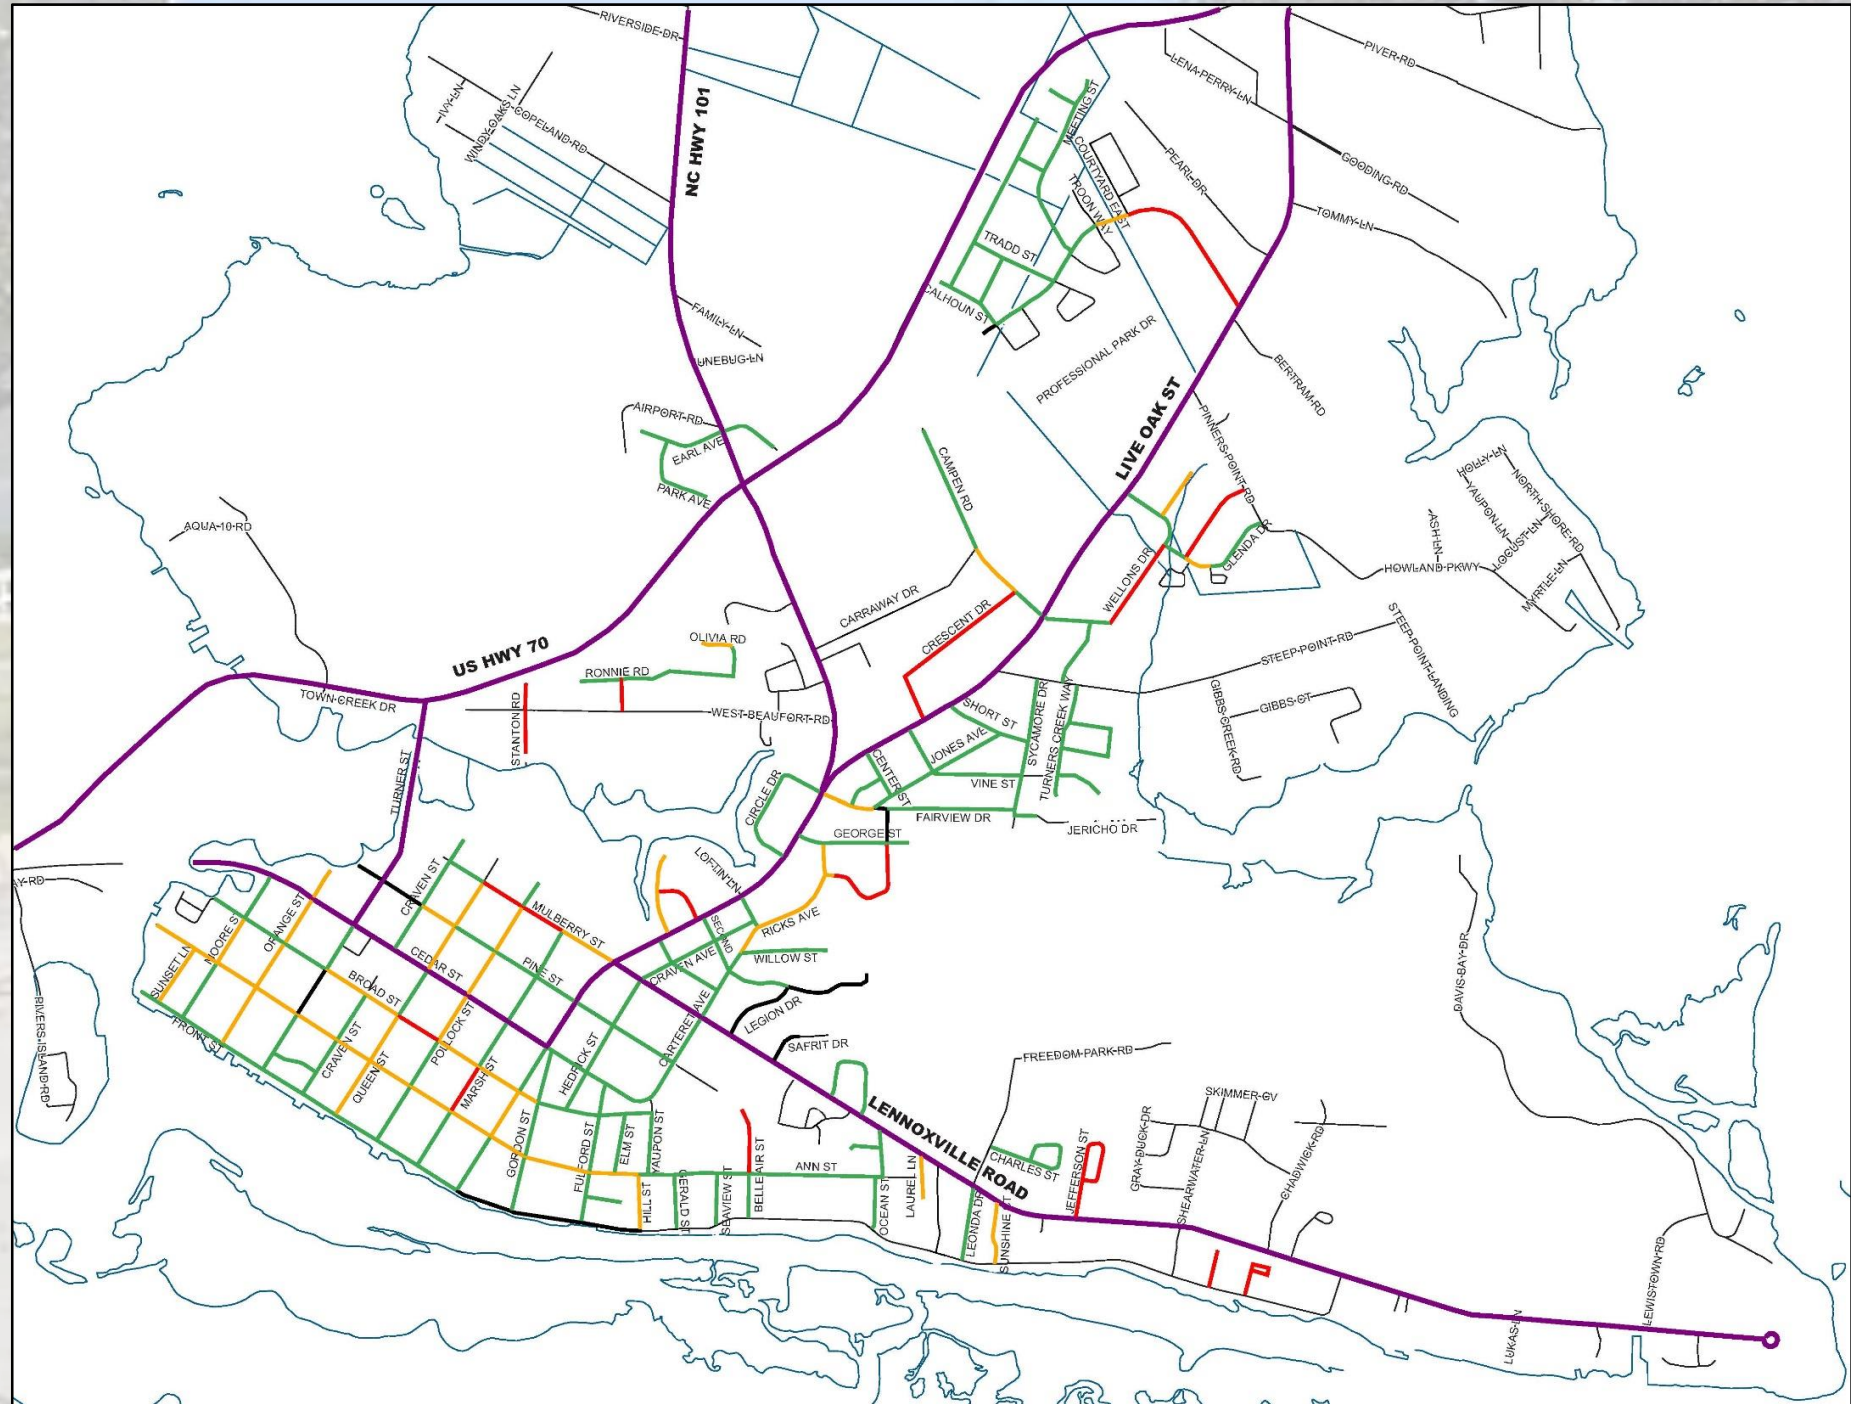
# 2018 Surface Distress Index

SDI Range	Surface Distress	# of Sections	Length (LN-MI)	% of Network
SDI < 20	Failed	2	0.4	1
$20 \leq \text{SDI} < 50$	Poor	18	4.7	10
$50 \leq \text{SDI} < 70$	Fair	58	9.1	19
SDI $\geq 70$	Good	192	32.9	70

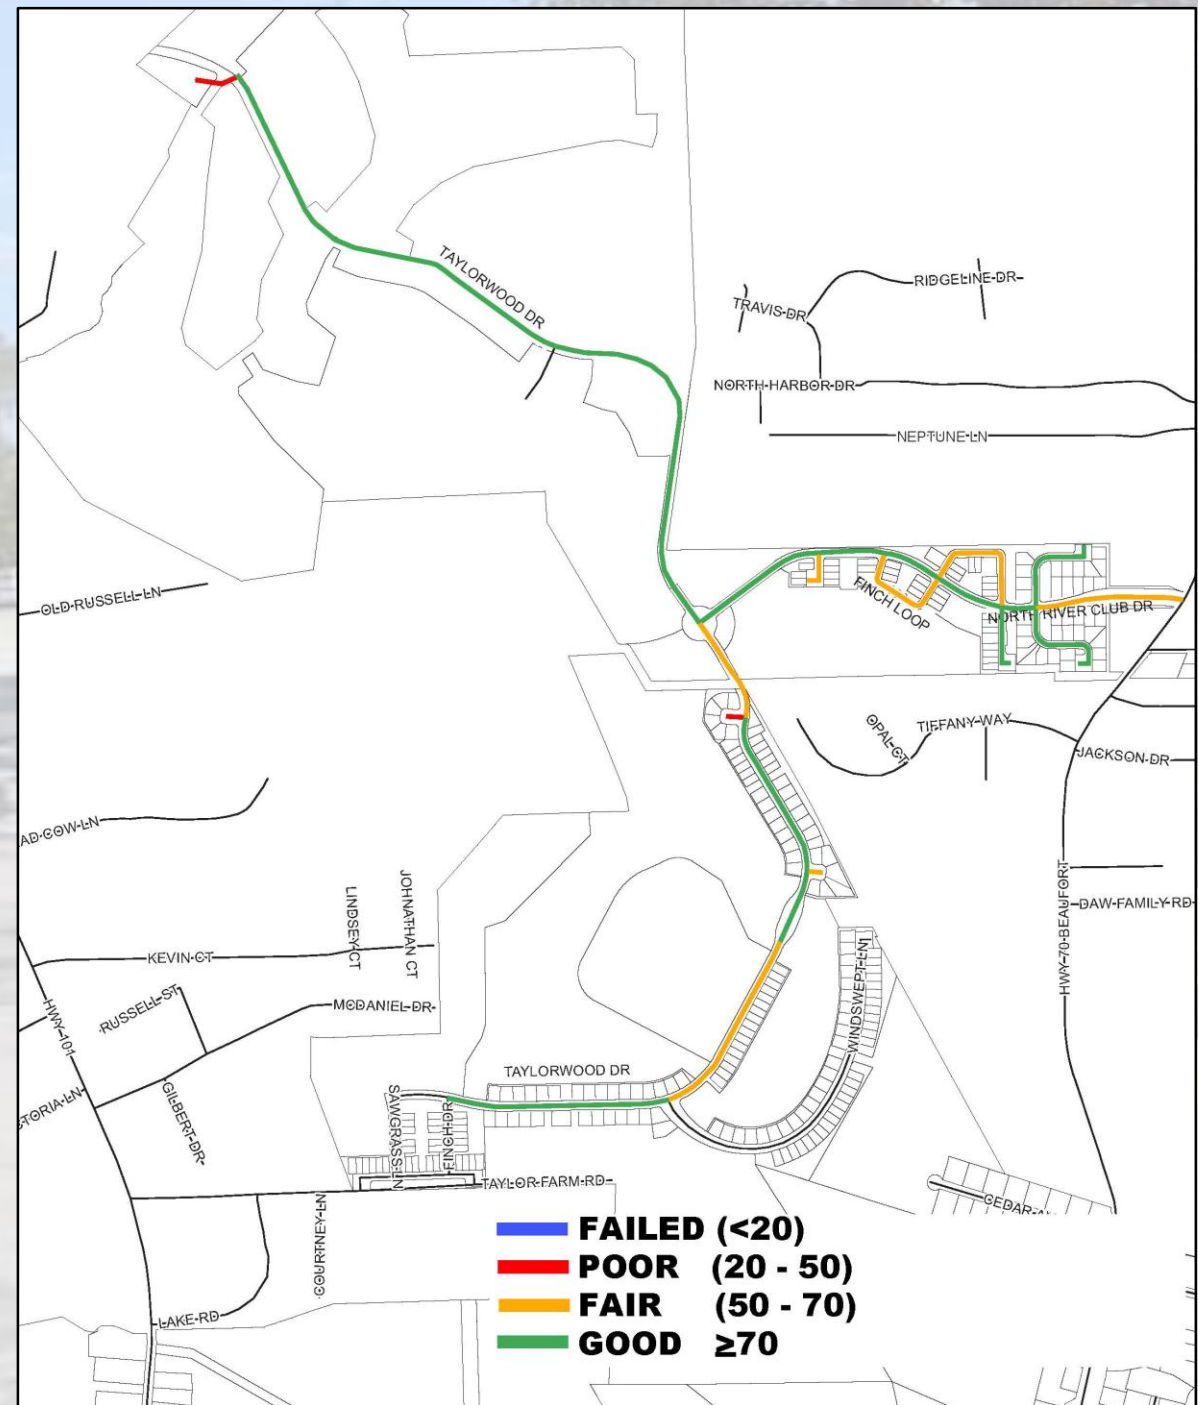
# 2018 Riding Comfort Index

RCI Range	Ride Quality	# of Sections	Length (LN-MI)	% of Network
RCI < 20	Failed	1	0.1	0
$20 \leq \text{RCI} < 50$	Poor	127	19.7	42
$50 \leq \text{RCI} < 70$	Fair	123	22.5	48
RCI $\geq 70$	Good	19	4.8	10

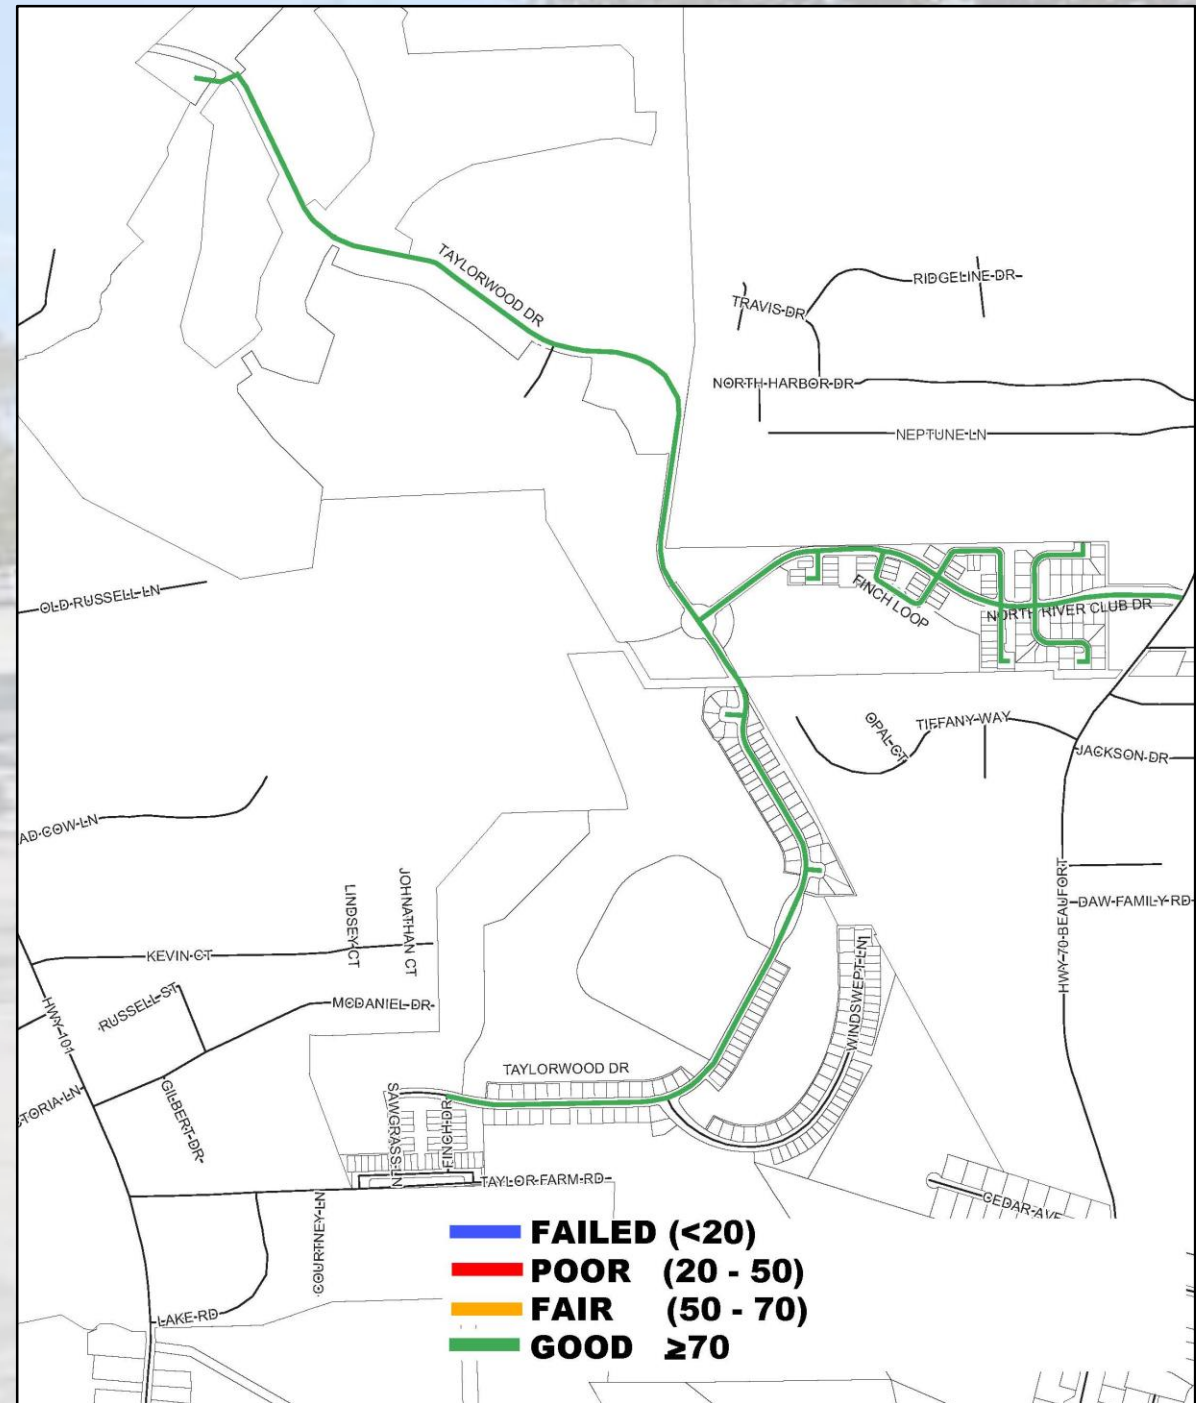
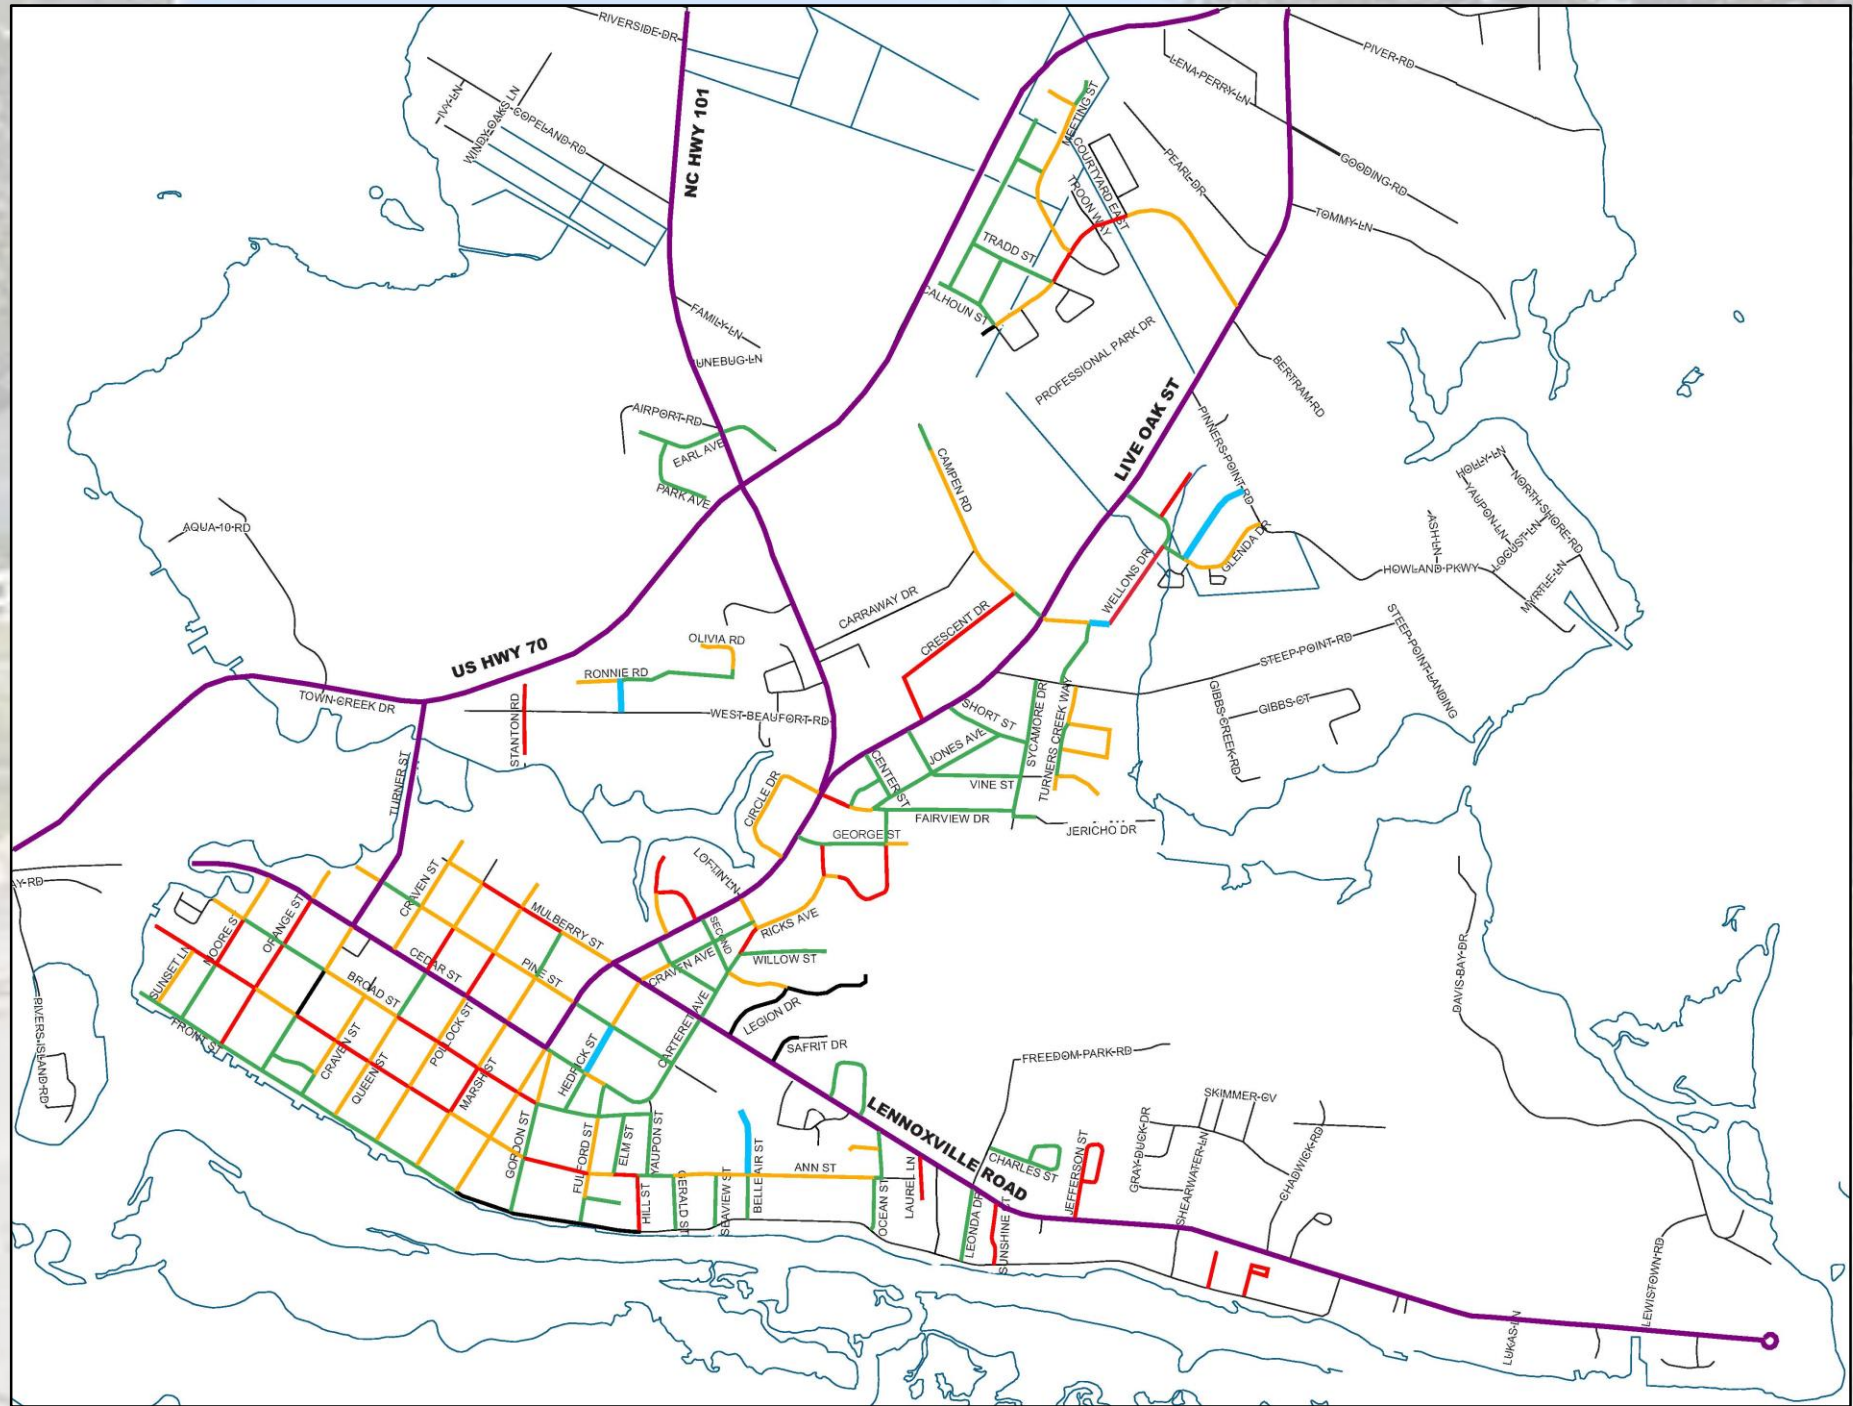
# 2018 Pavement Quality Index

PQI Range	Overall Performance	# of Sections	Length (LN-MI)	% of Network
PQI < 20	Failed	5	1.0	2
$20 \leq \text{PQI} < 50$	Poor	44	8.5	18
$50 \leq \text{PQI} < 70$	Fair	89	14.8	32
$\text{PQI} \geq 70$	Good	132	22.8	48

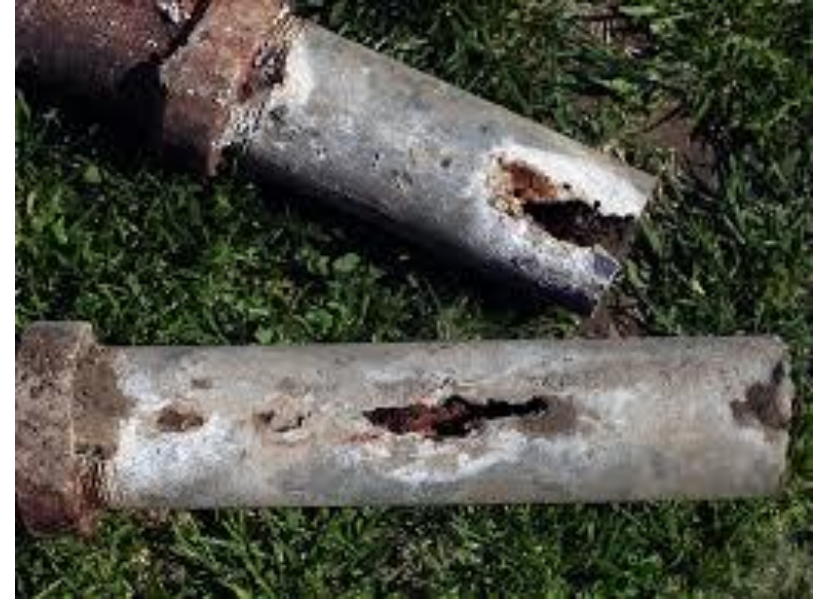
- Old Water Lines
  - Galvanized Pipe

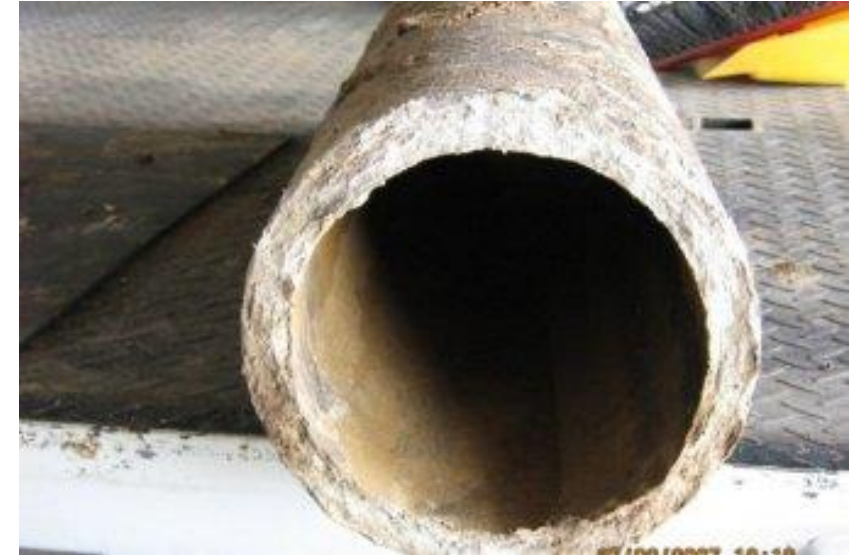
- Old Water Lines
  - Galvanized Pipe
  - Asbestos Cement Pipe

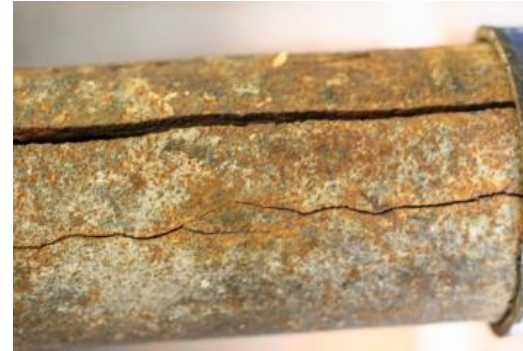
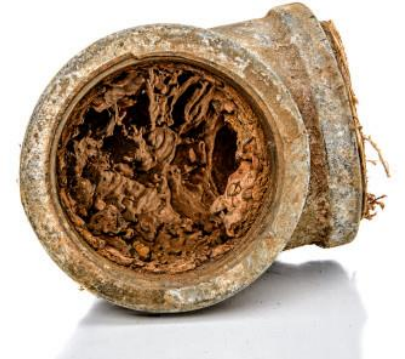
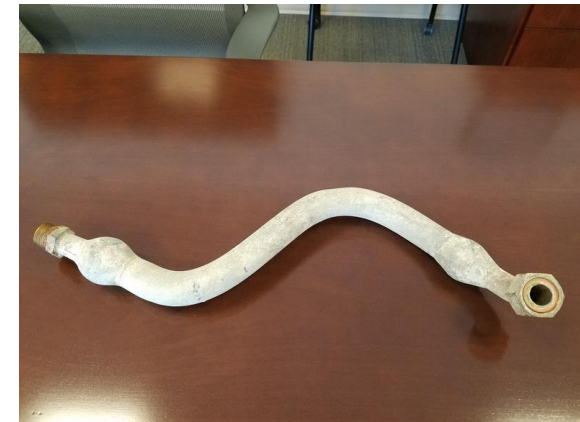
- Old Water Lines
  - Galvanized Pipe
  - Asbestos Cement Pipe
  - Cast Iron Pipe

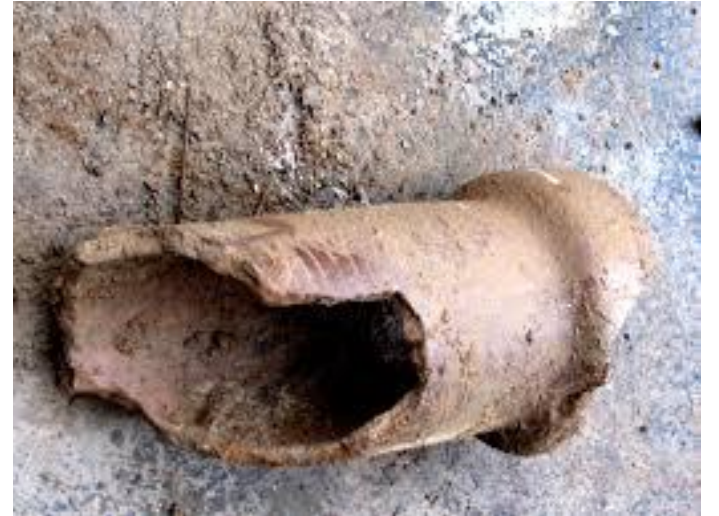
- Old Sanitary Sewer Lines
  - Vitrified Clay Pipe

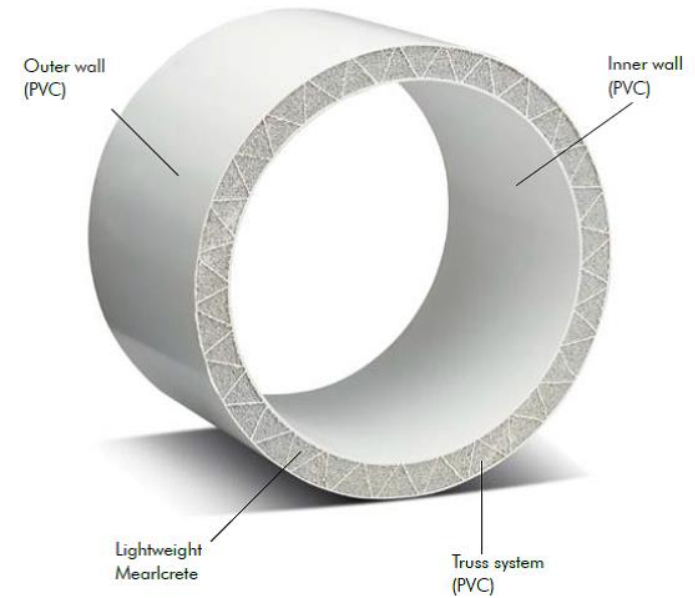
- Old Sanitary Sewer Lines
  - Vitrified Clay Pipe
  - Truss Pipe
