# Waterfront Condition Assessment

Produced for Town of Beaufort, NC

January 6, 2022 Final

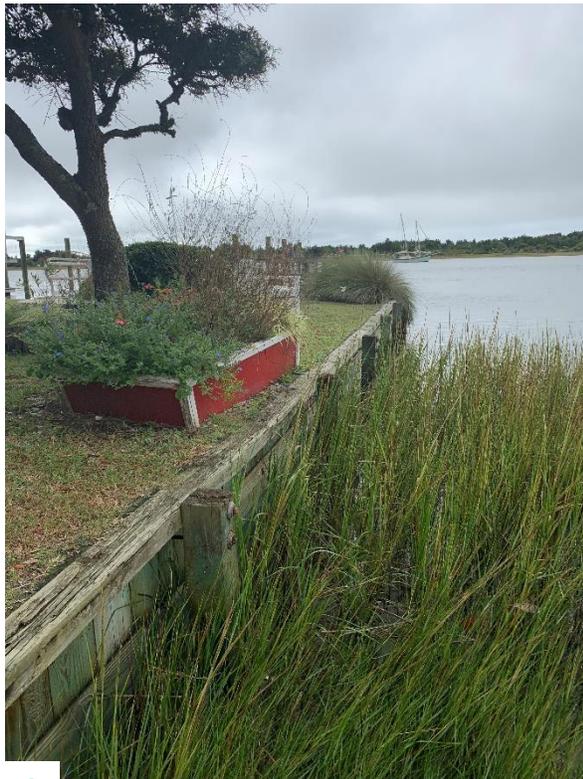
A

FIGURE 2-1: A. TIMBER BULKHEAD AT GRAYSON PAUL PARK B. TYPICAL TIMBER BULKHEAD DESIGN

The condition of the timber sheet piles, wale beams, and face piles were consistent with the age of the structure (approximately 10 to 15 years). The alignment of the wall was straight, with no seaward tilting of the bulkhead noted. Depressions in the soil behind the upper waler/cap were not observed, indicating that the timber sheets and the joints between the sheets have not deteriorated due to rot such that their integrity has been compromised, consistent with the observable portions of the timber bulkhead. The timber cap (upper waler) and some of the face piles exhibit signs of rot, with cracking and delamination. The anchoring hardware (tie-rod and fasteners) exhibit light corrosion.

The repair to the timber bulkhead is considered typical maintenance required to maintain the integrity of the structure through the remainder of its service life, estimated to be approximately 15 years. The upper wale beam should be replaced within the next 5 years along with fasteners that exhibit significant corrosion. The wale beam may be replaced in kind with marine grade southern pine or another type of exotic lumber such as greenheart or purpleheart. Copper and/plastic caps to the top of the face piles is suggested to minimize water penetration.

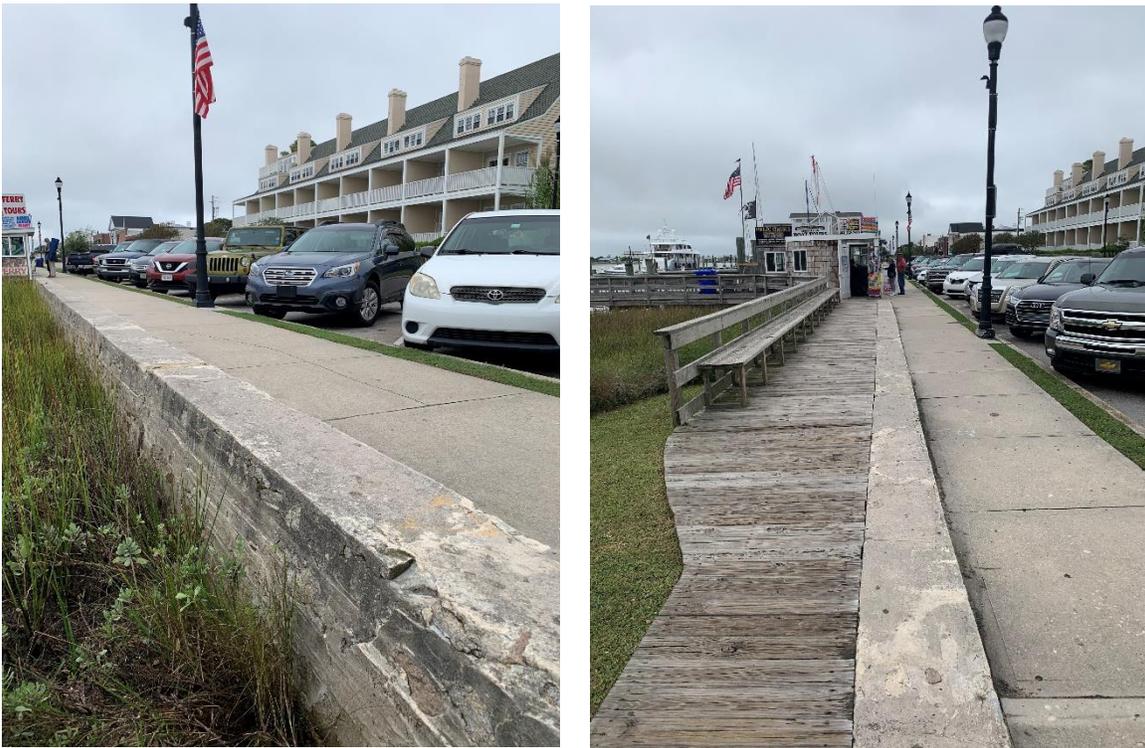
**FIGURE 3-1: STONE AND MASONRY GRAVITY WALL**

The condition of the stone and masonry gravity wall is rated as good based on the observations of exposed areas of the wall. Seaward rotation of the wall was not observed along the 550-foot-long segment. Open spalling of the masonry was noted at most expansion joints. Loss of granite stones were observed at several locations on the seaward edge of the masonry cap along a 75-foot section west of Grayson Paul Park.

The remaining service life of the gravity wall is estimated to be greater than 20 years unless conditions changes or rotation of the wall is detected. The repairs to the wall are intended to minimize water intrusion into the masonry where it may be lead additional spalling of the wall. It is assumed that approximately 25% of the wall should be repaired at this time. Spall repair consists of chipping off loose masonry and cleaning all exposed repair surfaces, adding a cementitious epoxy resin bonding primer to the exposed repair surface and placement of repair mortar or grout within a prepared form.

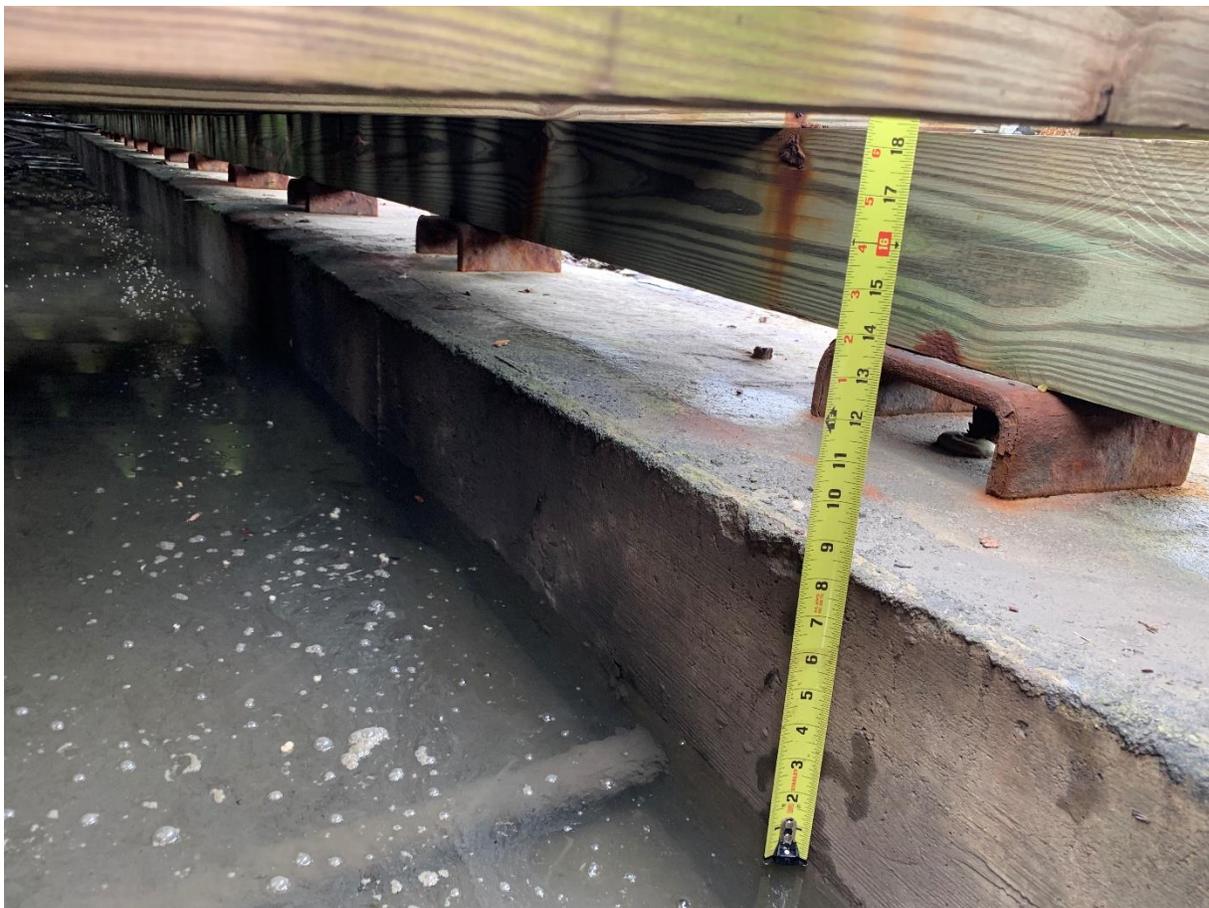
**FIGURE 4-3: WATER LEVEL ON LANDSIDE OF BULKHEAD WITH SUBMERGED TIE-RODS**

A typical maintenance issue for concrete sheet piles is a failure at the interlock between sheet piles. The interlock is the joint between adjacent sheet piles as shown in Figure 4-2 below. Due to differential movement between piles, or cracks and spalls at the interlock, it can be possible for water to flow through the interlock. This can lead to sediment transfer through the bulkhead and voids in the backfill. It was observed that the backfill varied from approximately 12 to 18" below the top of the pile cap beam and that as the water level rose along the pile cap beam, water behind the bulkhead was at approximately the same elevation as observed in Figure 4-3 and

Figure 4-4. This could be an indication that water is flowing through the interlocks. It is also possible that the bulkhead was constructed with a drainage system which is allowing the water levels to equalize on both sides of the wall, however no records or visual indications of a such a system were found.

To fully evaluate the condition of the concrete sheet piles, the interlocks, and check if any of the sheet piles have been undermined, it is recommended to perform an underwater dive inspection if the bulkhead system is not replaced.

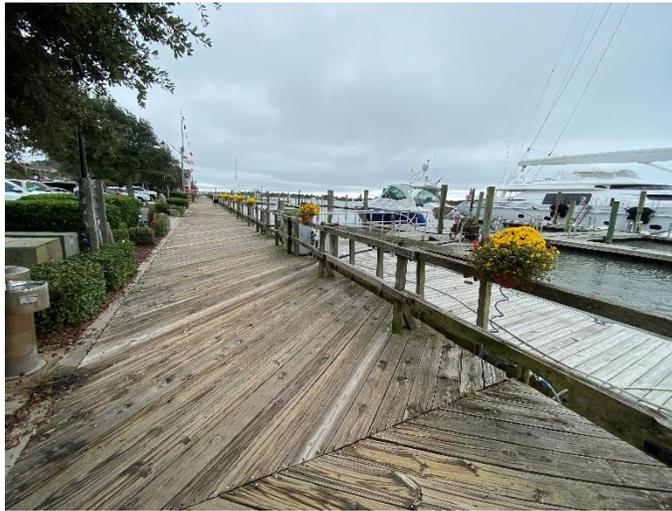
**FIGURE 5-1: TIMBER BOARDWALK VIEWING EAST**

The timber boardwalk presents an ongoing maintenance item for the Town of Beaufort as exemplified by the multiple deck boards that have been replaced. The settlement of the foundation on the landward side of boardwalk provides an uneven walk path that does not meet transverse slope requirements as outlined in ADA standards for accessible routes to buildings and recreational facilities such as piers, platforms, and boating facilities.

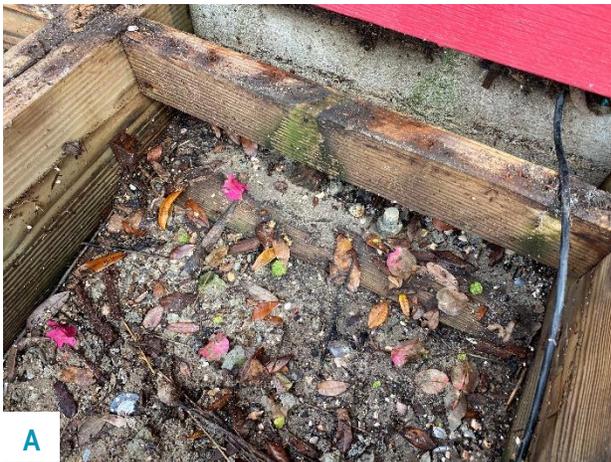
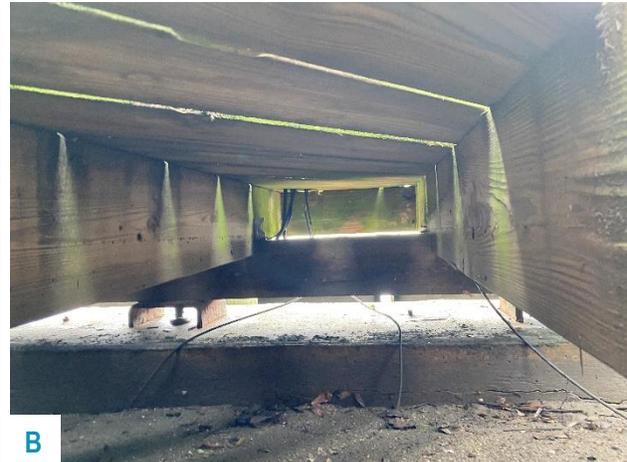
**FIGURE 5-2: TIMBER BOARDWALK SUPPORTS. A. LANDSIDE AND B. WATERSIDE**

M&N was provided with elevations that were taken along the boardwalk in 2017 and October 2021 by the Town of Beaufort. These elevations showed that along the waterside edge of the boardwalk there is approximately 1-inch of variation in elevation, however along the landside edge of the boardwalk there is 6 to 7-inches of variation in elevation. The readings in 2017 and 2021 are not aligned but trending elevation variations indicate that settlement of the boardwalk on its landside edge occurred prior to 2017.

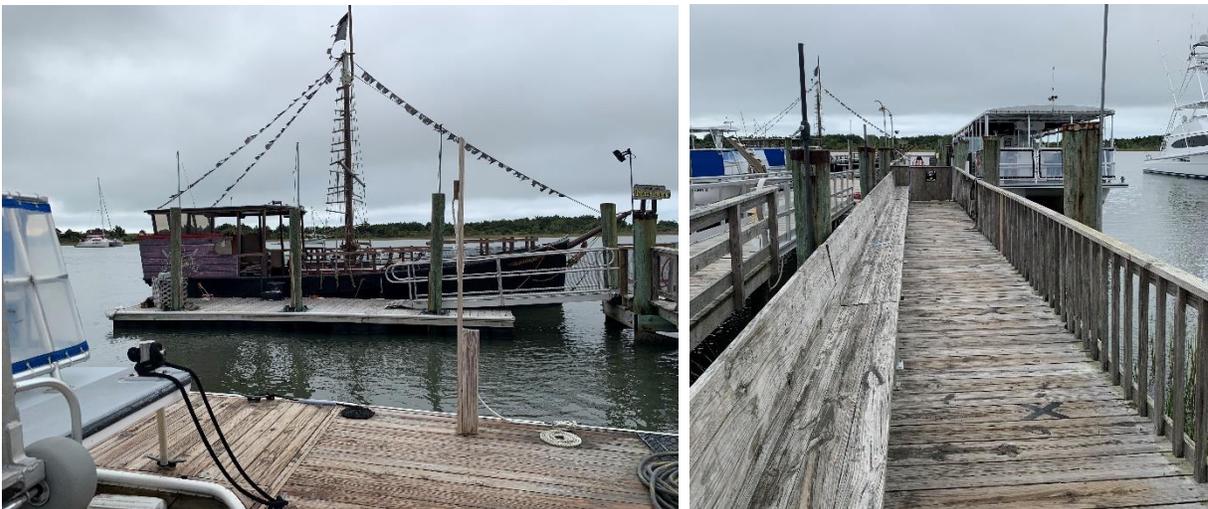
**FIGURE 6-1: PIRATES REVENGE FIXED AND FLOATING INFRASTRUCTURE**

The timber decking of the fixed dock is in moderate condition based on age of facility. The timber handrail is primarily a picket style design with some modified handrails with steel mesh at the gangway access point to the floating dock. The floating dock system is in moderate condition, exhibiting reduced buoyance and freeboard in the longitudinal and traverse directions.

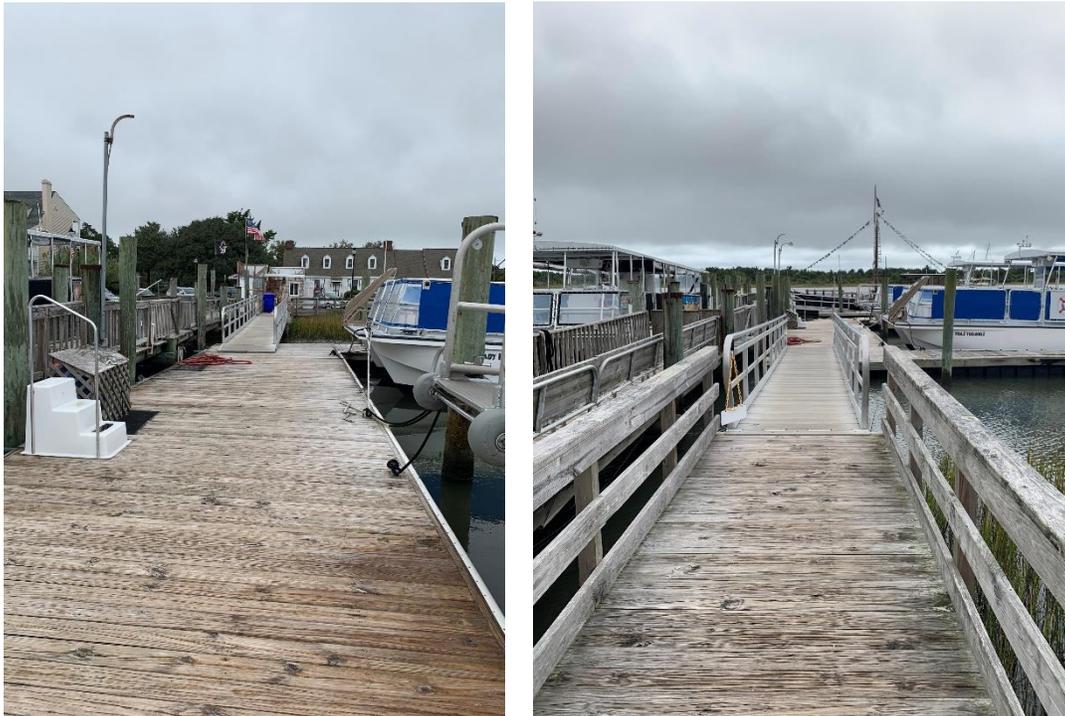
**FIGURE 6-2: ISLAND FERRY DOCK**

The two concessionaire docks are connected to a 150-foot long by 3-foot to 6-foot-wide fixed timber boardwalk that parallels the stone and masonry gravity wall and the concrete sidewalk. This boardwalk shows moderate wearing of deck boards.

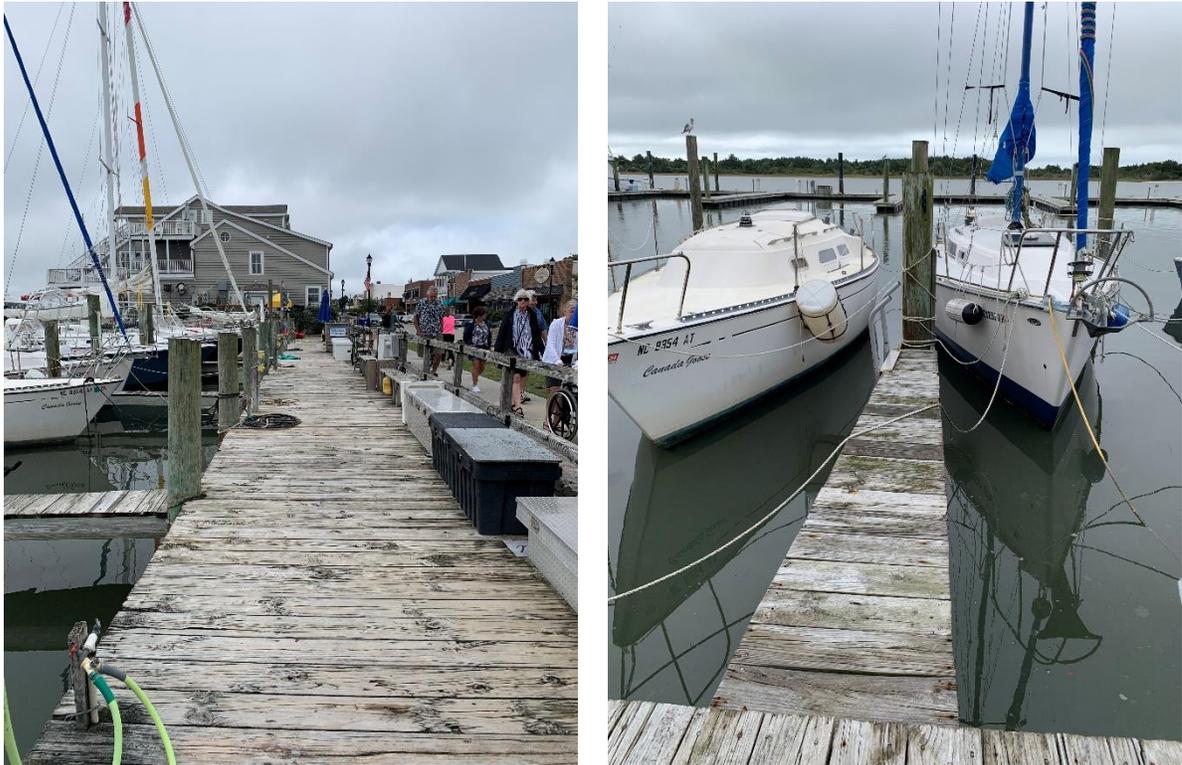
**FIGURE 6-3: FIXED DOCK INFRASTRUCTURE – BEAUFORT DOCK**

The fixed dock infrastructure is in fair condition overall with observed necking and section loss of several timber mooring and pier support piles. Several of these timber piles were easily moved in the lateral direction when pushed, which may indicate that the pile has limited lateral capacity. The timber dock boards are in poor condition on the finger piers and fair condition on the shore parallel dock. The connections and overall condition handrail along the north side of the shore parallel dock may not meet Town building code.

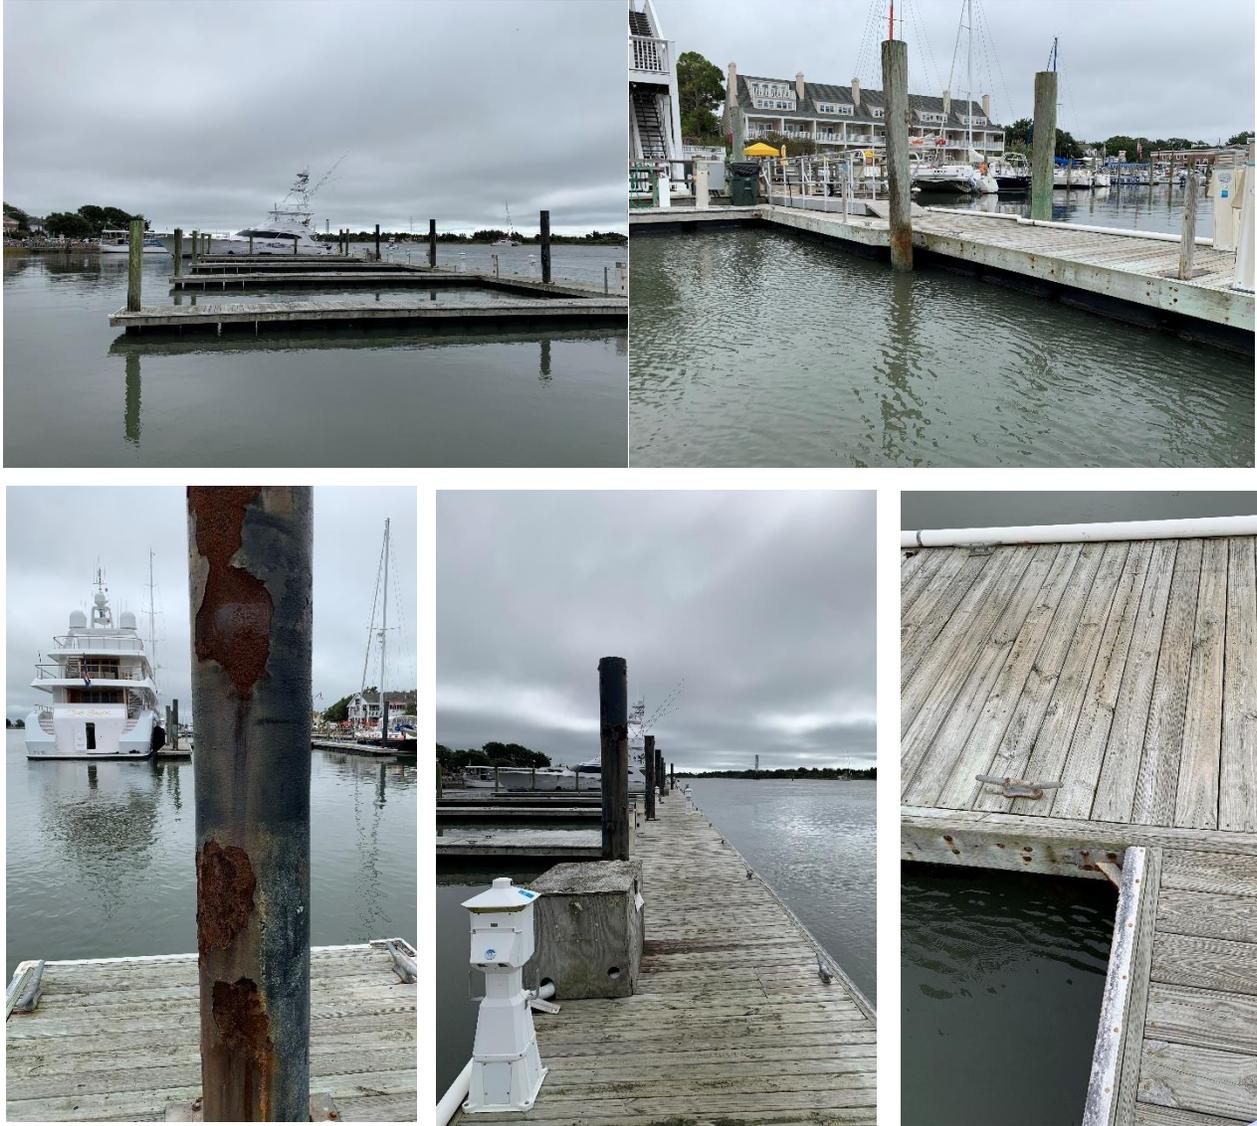
**FIGURE 6-4: FLOATING DOCK INFRASTRUCTURE AT BEAUFORT DOCKS**

Figure 6-4 indicates that the floating dock infrastructure is in fair condition overall, consistent with the age of system (15 to 20-years). There is observable sagging and heeling of the main and finger piers due to warping of timber structural members and absorption of water within the flotation billets. In addition, the connection hardware between the main and finger docks has corroded, leading to excessive movement of the finger pier when walking on it.

The floating docks are anchored by steel pipe piles with timber piles primarily anchoring the shore parallel dock. Pile guides to transfer load from the piles to the floating dock were missing in several locations. Excessive movement and necking/checking of the timber guide piles were observed. Similar conditions were noted for the timber mooring piles separating the double berth slips. Surface corrosion of the steel pipe piles was also evident at the waterline and free height areas.

The floating dock infrastructure at the Beaufort Docks have a remaining service life of 10 to 15-years. This timeframe is consistent with an average design life of a floating dock system, which ranges from 20- to 30-years depending on construction material types and performance of routine maintenance. A percentage of timber framing and decking should be replaced to prolong the infrastructure. Additional maintenance considerations include replacing or adding flotation billets, the metal fasteners and connection hardware between the finger piers and main dock, and pile guides and associated rollers were missing or inoperable.

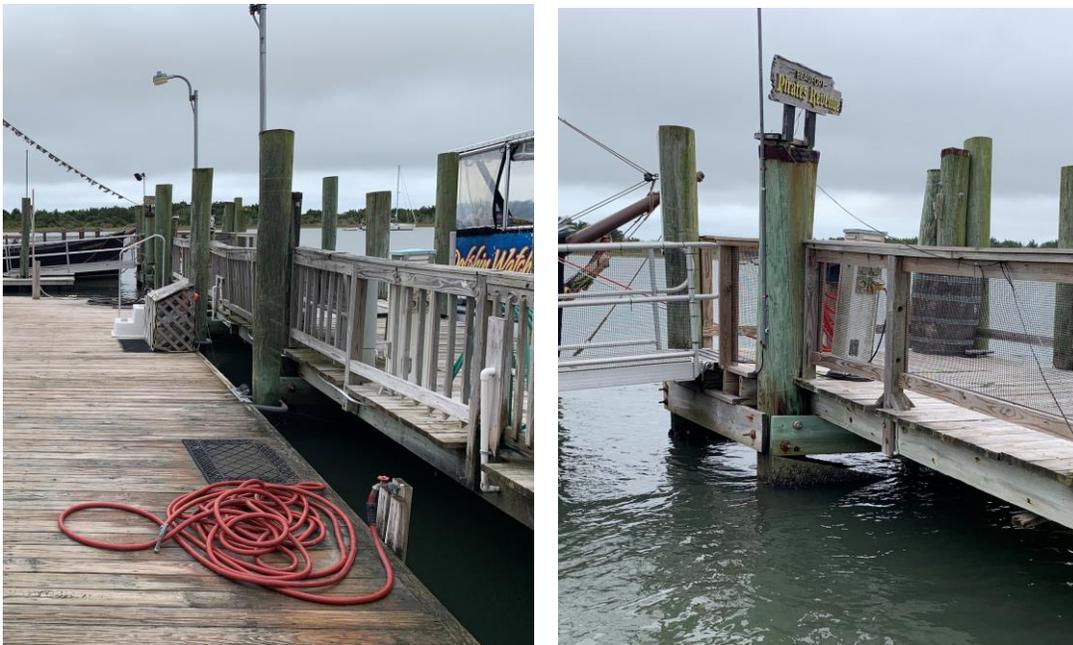
**FIGURE 7-1: UTILITY SERVICES – TOWN/CONCESSIONAIRE DOCKS**

Potable water service is provided at the Island Ferry and Pirates Revenge docks as shown in Figure 7-1. This service consists of PVC supply line that feeds several PVC pipe risers mounted on a 2x4 or 2x6 timber backer board. Galvanized metal hose bids without frost protection are attached to the risers. Overall condition of the system is fair to good. The only consideration on the overall system is the degradation of PVC pipe due to UV exposure.

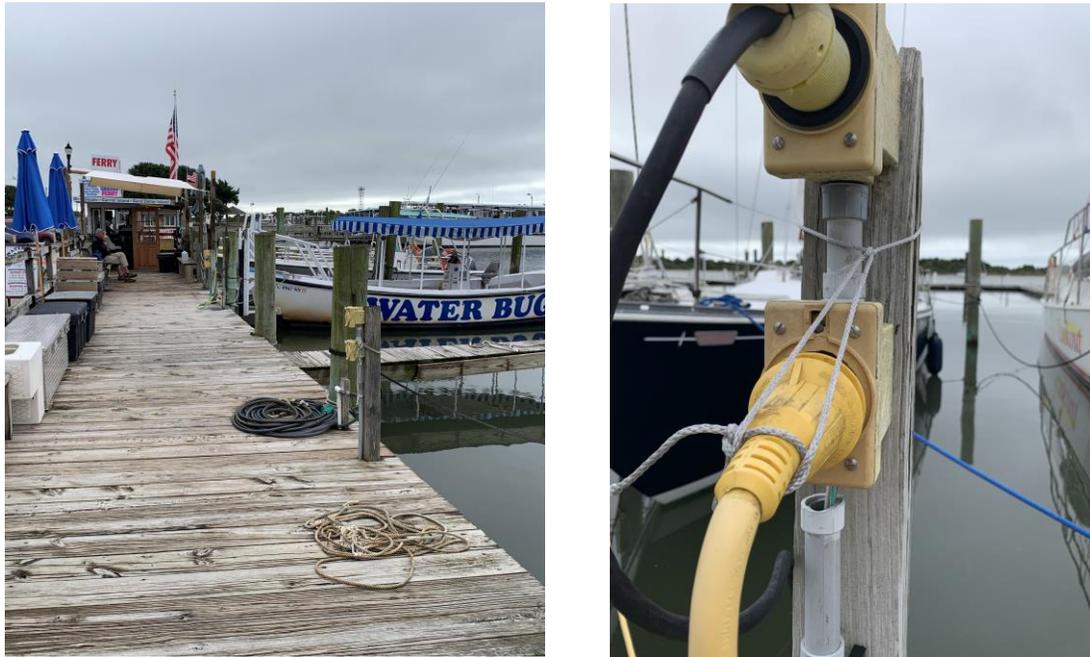
**FIGURE 7-2: ELECTRICAL SERVICE – EAST SIDE BEAUFORT DOCKS**

The east end of the marina is primarily 120-volt service on the standalone 2x4 timber risers with single receptacle for each slip as shown in Figure 7-2. Shore power for the slip where the 45-foot catamaran for Lookout Cruises is berthed has 50-amp 120/240-volt service receptacle. The shore power for the 50- and 50-foot slips in floating dock sections of the marina is 30- and 50-amp 120/240-volt receptacles housed in standalone timber risers or various aluminum cased power centers as shown in Figure 7-3. The 100-amp 208-volt three phase and 100-amp 120/250-volt single phase services are located on standalone timber risers as well as shown in Figure 7-3.

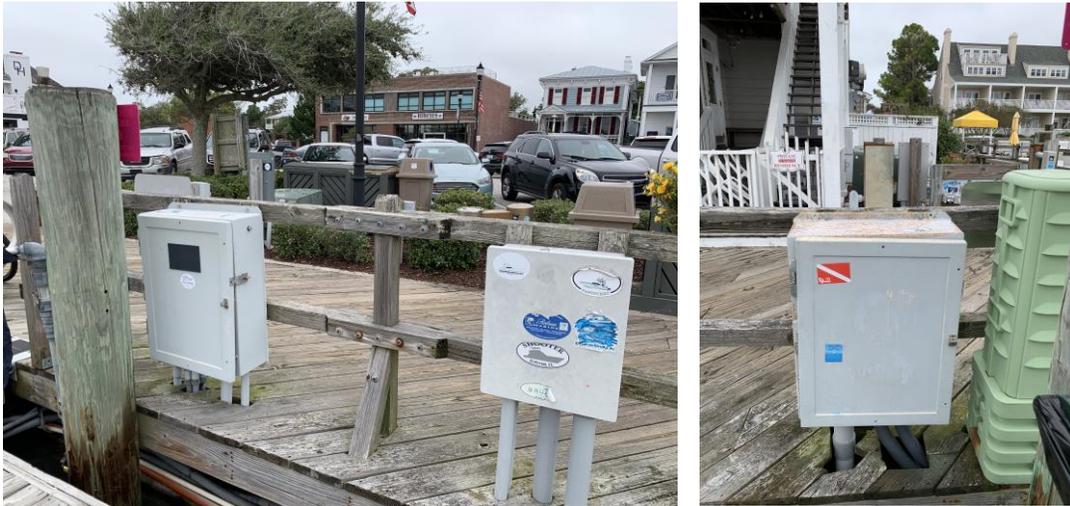
**FIGURE 7-4: ELECTRICAL DISTRIBUTION EQUIPMENT**

The panel boards and electrical distribution equipment for the shore power is located on the Town's boardwalk, adjacent to all gangway access points to the floating docks as shown in Figure 7-4. The equipment is not elevated above FEMA's 100-year base flood elevation (BFE), indicating the original equipment was installed prior to changes in the National Electrical Code (NEC) that mandate equipment be raised 2 to 3 feet above the BFE. The overall condition of the equipment is fair with the reliability of the system unknown.

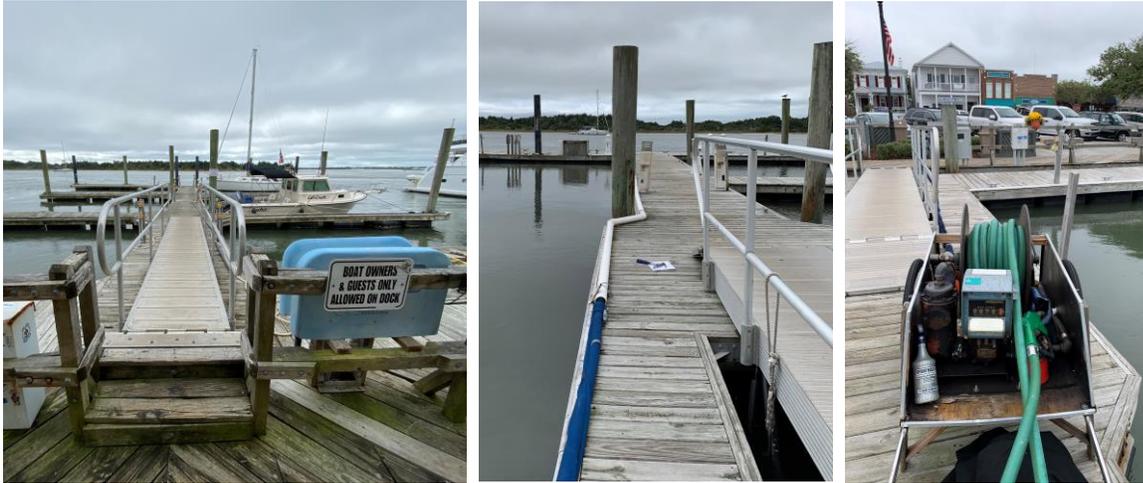
**FIGURE 7-5: SANITARY PUMPOUT AND FUELING FACILITIES**

Mechanical equipment includes potable water service that is standalone (similar PVC riser mount) or integrated into the power centers, a central sanitary pump-out unit on the west end of the facility, and diesel fuel delivery at each slip using fixed dispenser stations or mobile dispenser carts. Individual fire extinguishers mounted in cabinets are the only fire suppression system on the docks. Figure 7-5 shows the sanitary pumpout unit and the mobile fuel carts.

As noted earlier in observations for the east docks, the PVC risers for the potable water service are exposed to UV conditions, which may reduce their long-term reliability. The sanitary pumpout is a functioning system that will continue to support marina operations assuming routine maintenance is performed. If there is a desire to expand the system to other parts of the marina or upgrade the system, the grants from the State of North Carolina used for the purchase and installation of the present system may be applied and received for a new system.
