# Waterfront Condition Assessment

Produced for Town of Beaufort, NC

January 6, 2022 Final

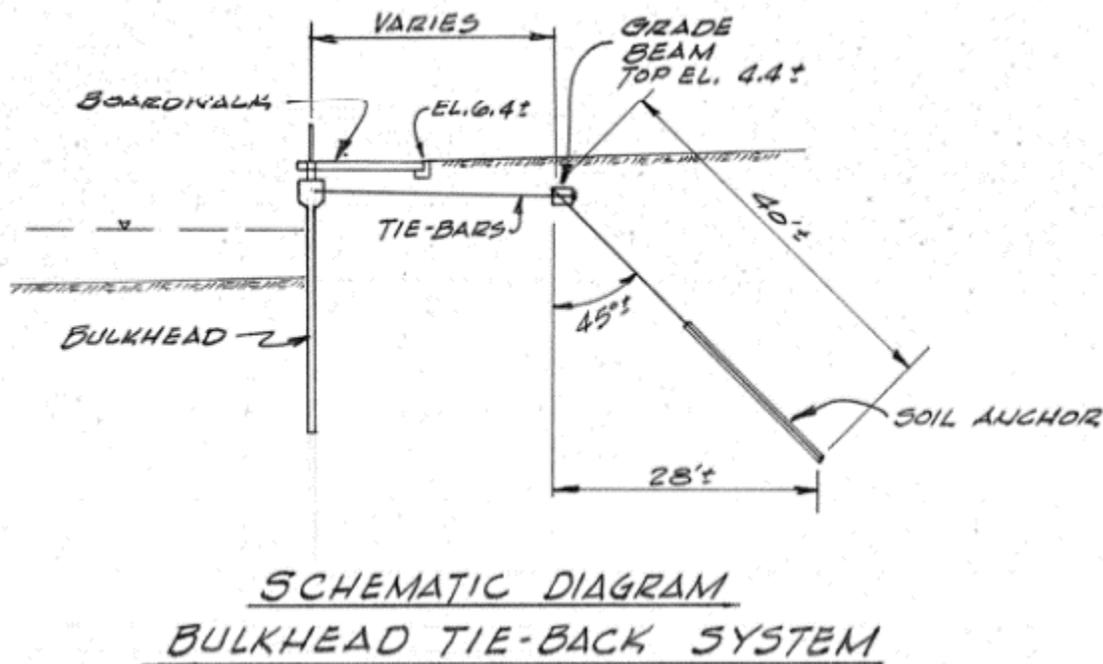
**FIGURE 4-1: HISTORIC CROSS SECTION**

The concrete bulkhead is approximately 44 years old and consists of a 950-foot-long anchored concrete sheet pile wall with a reinforced concrete cap beam. According to the available record drawings (Figure 4-1), anchorage is provided by soil anchors set back from the bulkhead. Load is transferred by tie-rods which extend horizontally from the bulkhead cap to a grade beam beyond the boardwalk.

M&N has been provided multiple historic drawings by the Town of Beaufort. None of the historic information contain records on the design of the sheet piles, their length, their reinforcement, or the construction of the soil anchors. It is therefore not possible to accurately analyze the performance or load carrying capacity of the existing concrete bulkhead.

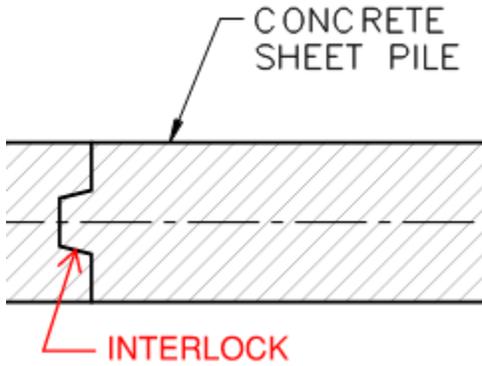
**FIGURE 4-2: EXAMPLE DRAWING OF A TYPICAL CONCRETE SHEET PILE INTERLOCK**

A typical maintenance issue for concrete sheet piles is a failure at the interlock between sheet piles. The interlock is the joint between adjacent sheet piles as shown in Figure 4-2 below. Due to differential movement between piles, or cracks and spalls at the interlock, it can be possible for water to flow through the interlock. This can lead to sediment transfer through the bulkhead and voids in the backfill. It was observed that the backfill varied from approximately 12 to 18" below the top of the pile cap beam and that as the water level rose along the pile cap beam, water behind the bulkhead was at approximately the same elevation as observed in Figure 4-3 and

Figure 4-4. This could be an indication that water is flowing through the interlocks. It is also possible that the bulkhead was constructed with a drainage system which is allowing the water levels to equalize on both sides of the wall, however no records or visual indications of a such a system were found.
